Leaks down the barrel

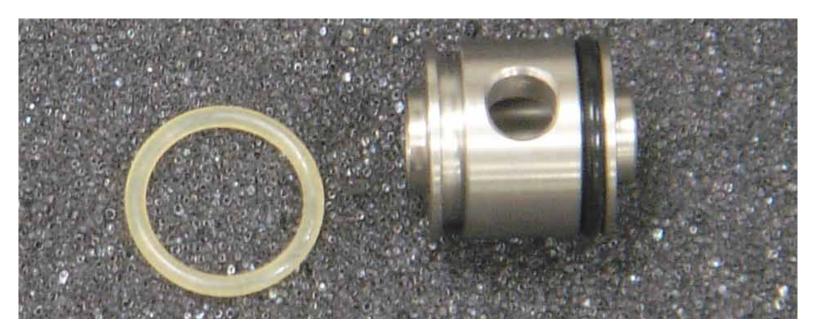
POSSIBLE CAUSE: Front Valve O-Ring (R012) is damaged.

SOLUTION: Replace Front Valve O-Ring.

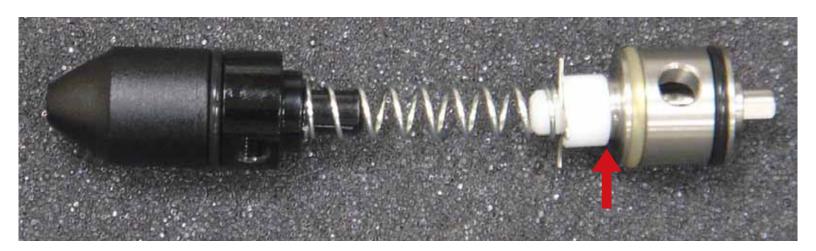
POSSIBLE CAUSE: Damaged Valve.

SOLUTION: Replace Valve.
